Manhole Inspection Summary

Manhole # S25GG_026MH

Location Address: **539 PRESSTMAN ST**

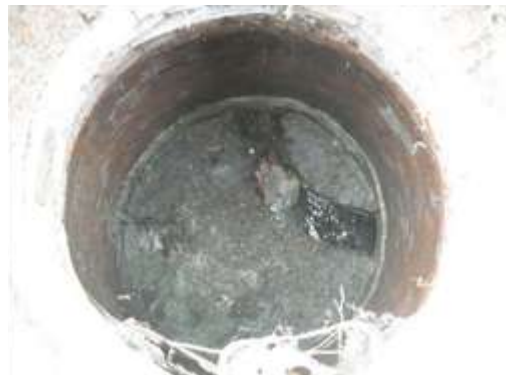
Top View

Evidence of surcharge - Bench debris.
Channel debris.

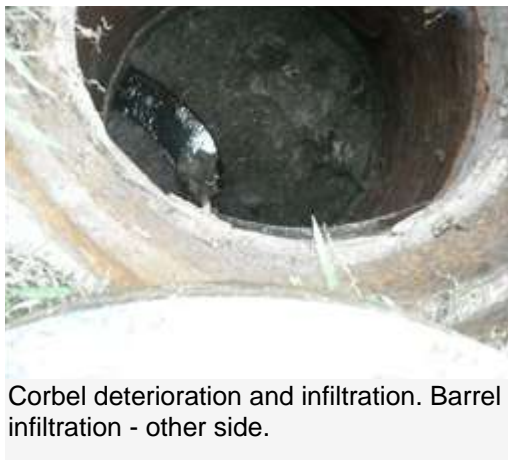
Defect

Corbel deterioration and infiltration. Barrel infiltration - other side.

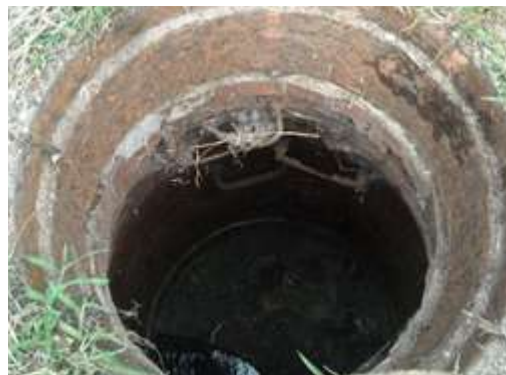
Defect

Corbel deterioration and infiltration. Barrel infiltration.

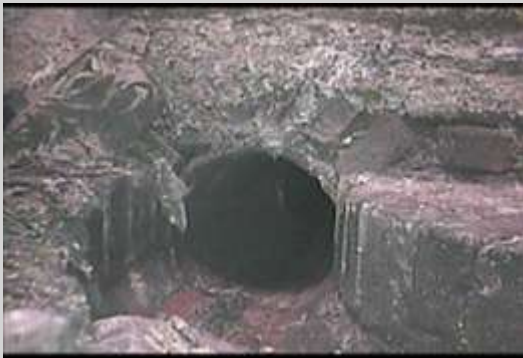
8 in. Circular Gravity Sewer Pipe Out @ 12 O'Clock

Invert Depth: **8.78** (ft.) Flow Characteristics: **Slow**

Deposits: ☒ None ☐ Mud ☐ Sludge ☐ Debris ☐ Grease

Infiltration: **None** Pipe Seal Cond: **Unknown**

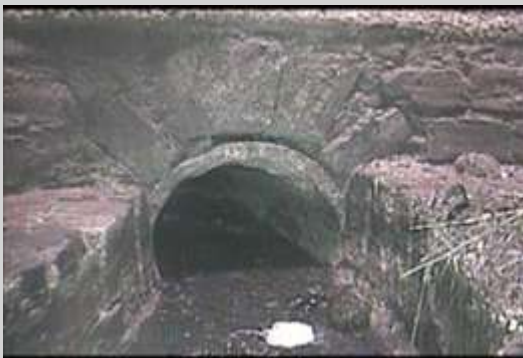
8 in. Circular Gravity Sewer Pipe In @ 3 O'Clock

Deposits: ☐ None ☒ Mud ☒ Sludge ☐ Debris ☐ Grease

Silt Depth: **2** (in.) Deposits Extent: **Light**

Infiltration: **None** Pipe Seal Cond: **Cracked**

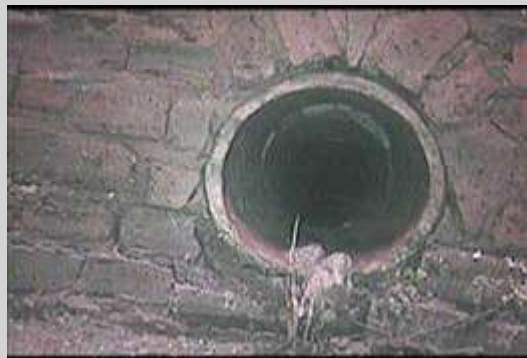
Pipe In @ 9 O'Clock

Infiltration: **Evidence**

Pipe Seal Cond: **Cracked**
